Recovering Performance Loss Due to Air Binding – A Case Study –

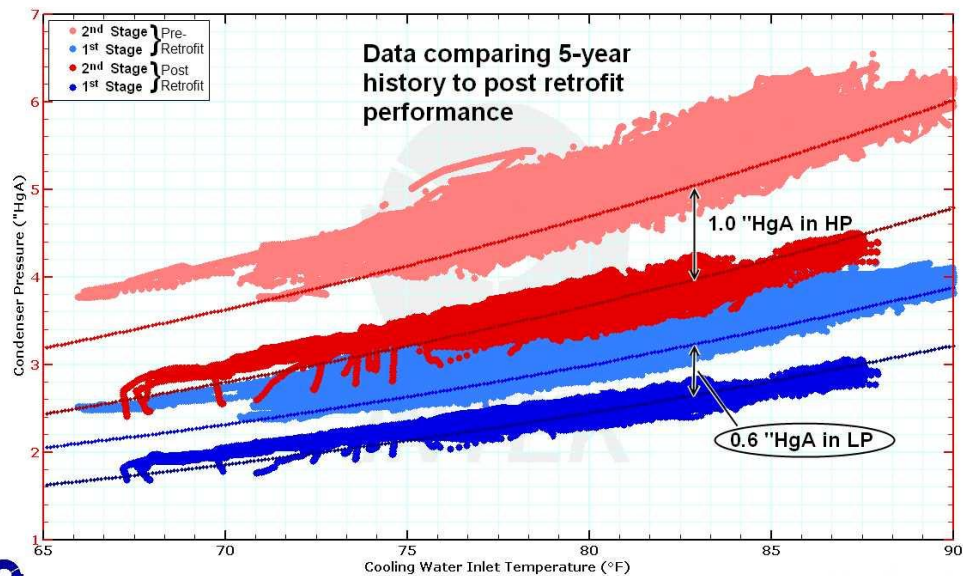
The first objective of the engineering study phase was to determine the magnitude of low condenser performance and also identify the root causes for the specific degradation mechanisms. The results of the initial study verified that the ball cleaning system was maintaining clean tube conditions and that air binding, despite low air in-leakage, was the overwhelming cause for the measured poor performance. Following the engineering study a proposal was accepted to alter the steam, condensate and noncondensable flows by installing a steam side condenser retrofit concurrent with the condenser retube. A comparison of the measured condenser pressures (5 minute averages) before (5 years prior) and after the condenser retrofit for the same condenser duty range is plotted in the figure below.
